**REPORT OF
STEAM RELEASE EVENT
EXTRACTION WELL EW-5
VISALIA STEAM REMEDIATION PROJECT**

Southern California Edison
Environmental Affairs Department

April 30, 1999

Preliminary analysis of the failure of well EW-5, Visalia Pole Yard, February 1, 1999

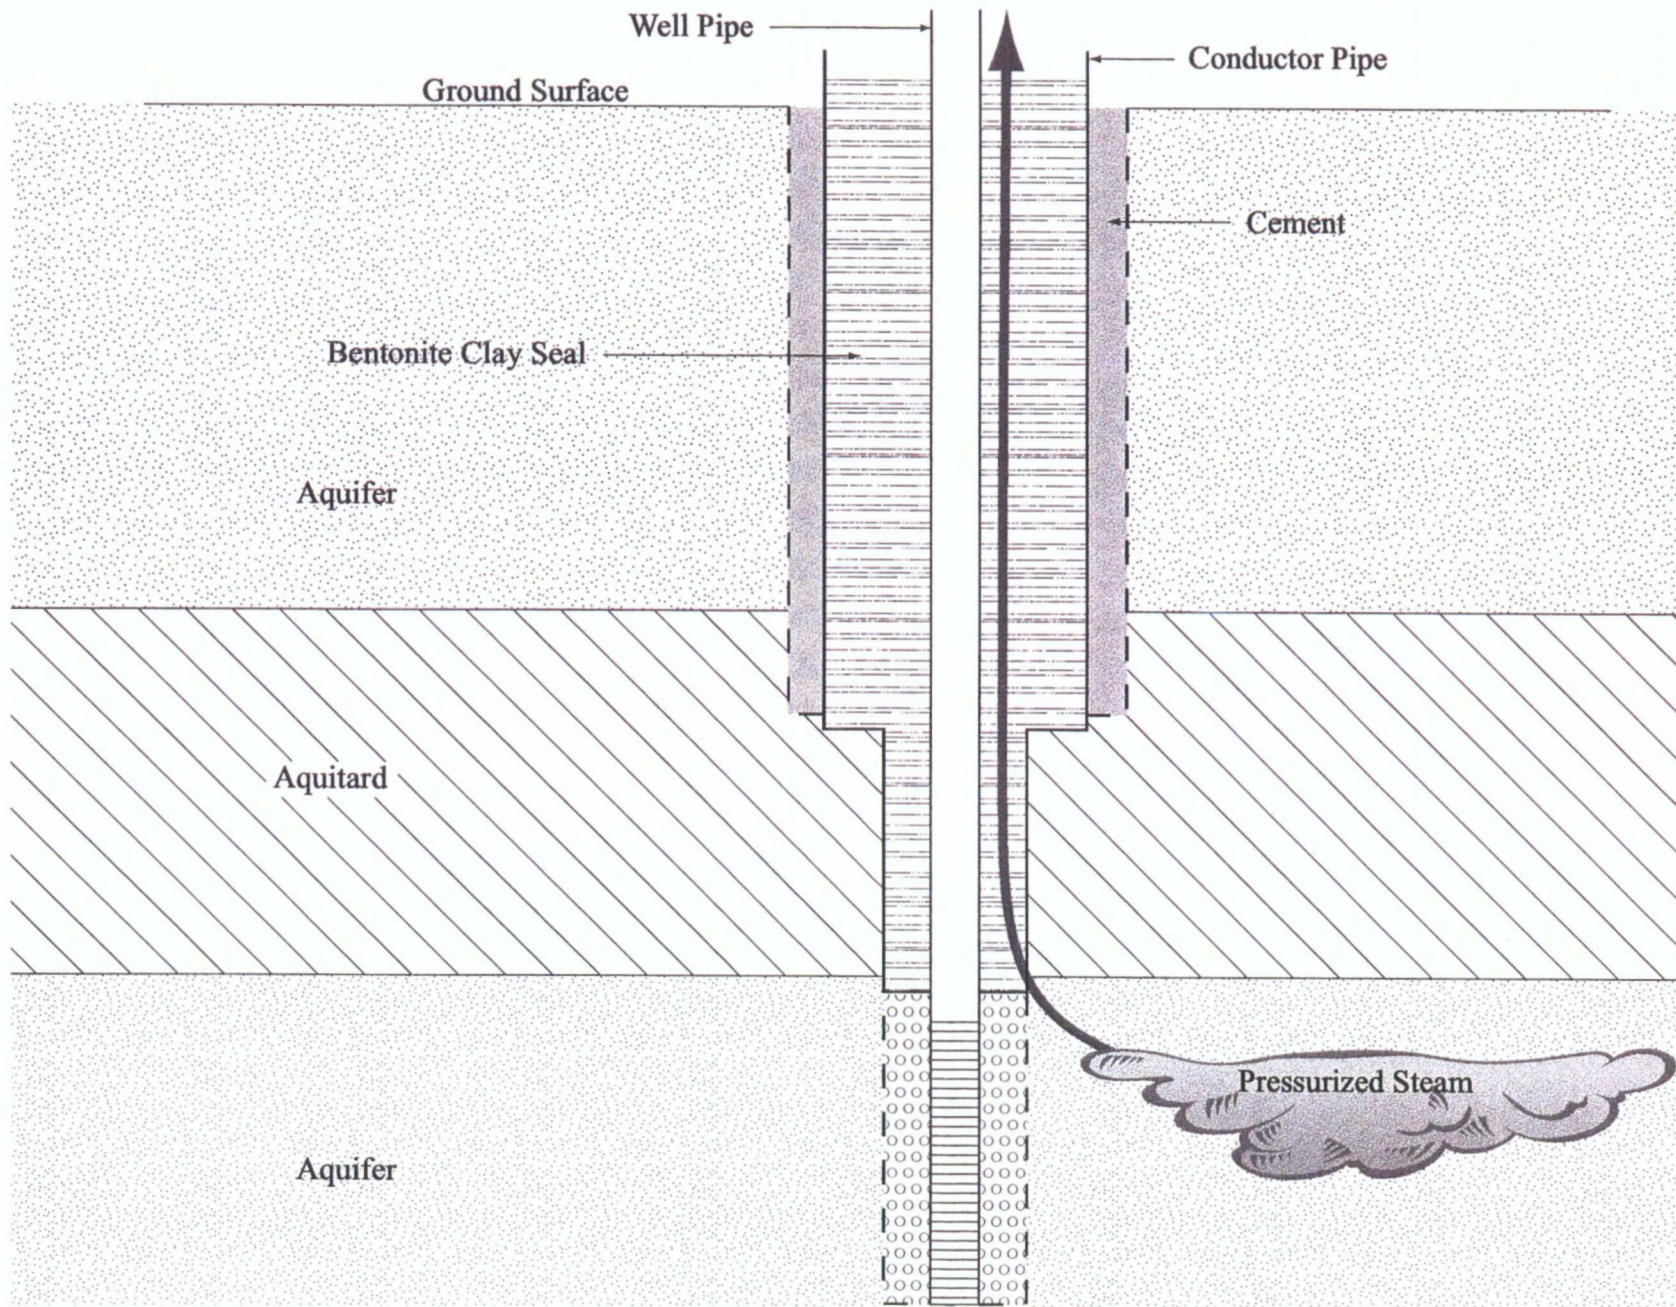
STEAM RELEASE PATHWAY
EW-5 EVENT
VISALIA POLE YARD

The steam release was caused by the failure of a bentonite seal, originally placed between the well and conductor casings during construction. Steam under a pressure of approximately 40 pounds per square inch (psi) is thought to have first eroded the bentonite borehole seal in the uppermost part of the deeper aquifer. It made its way upward into the annular space between the casings at a depth of approximately 107 feet, where the bottom of the conductor casing is located. From there the steam continued to erode the seal material until it reached the surface. A diagram of the well construction and steam release pathway is shown in the Steam Release Pathway figure. At the surface, the steam developed enough lifting force to break the concrete well slab, and vent to the atmosphere.

The source of this eruption was the 16" conductor. The conductor casing was filled with bentonite, which apparently became liquefied and lost strength, allowing bubbles of steam to rise through it, removing the bentonite. This assessment is based on the mud eruptions from MW-34 and the apparently low-energy mud splattering around EW-5; there are currently no eyewitness accounts to verify that mud came out slowly at the beginning of the event. Personnel from the Visalia City Corporation Yard should be consulted concerning supplying more information about this inference.

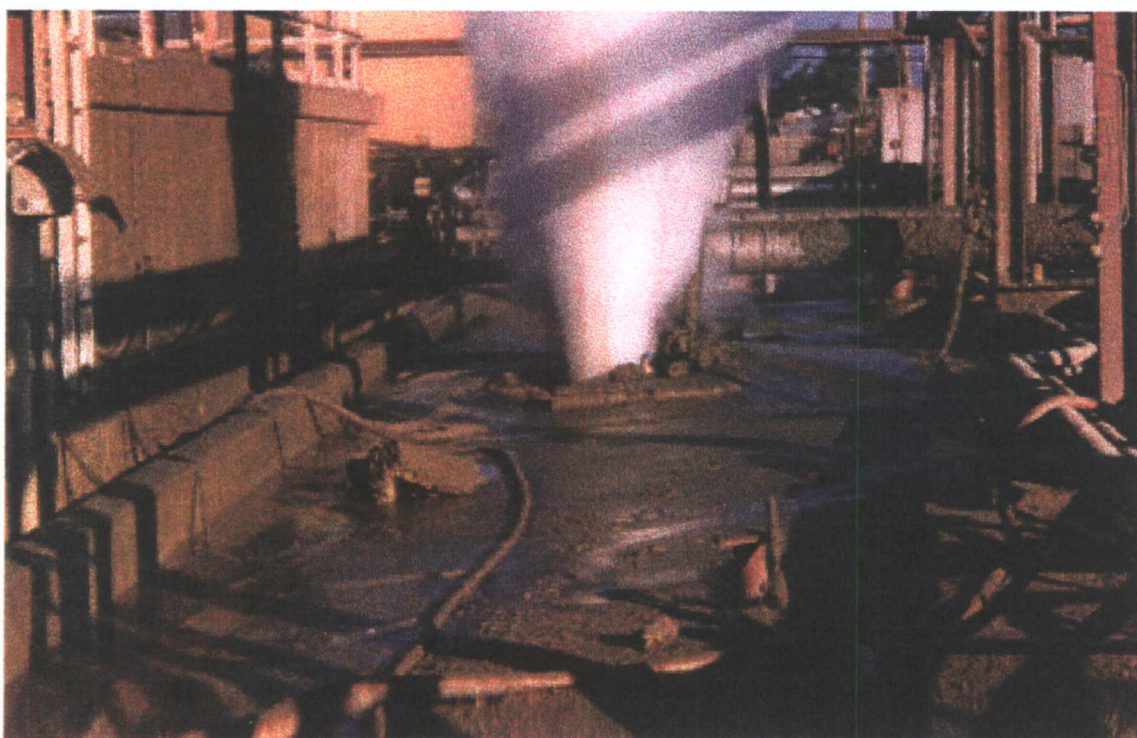
Geyser during eruption (from the west). A dislodged, triangular chunk of concrete from the well cap lies at center left. Streaks of brown silt may be seen in the plume. Bentonite that appeared to have erupted by an early, much less vigorous process is stuck to the separator wall at the left.

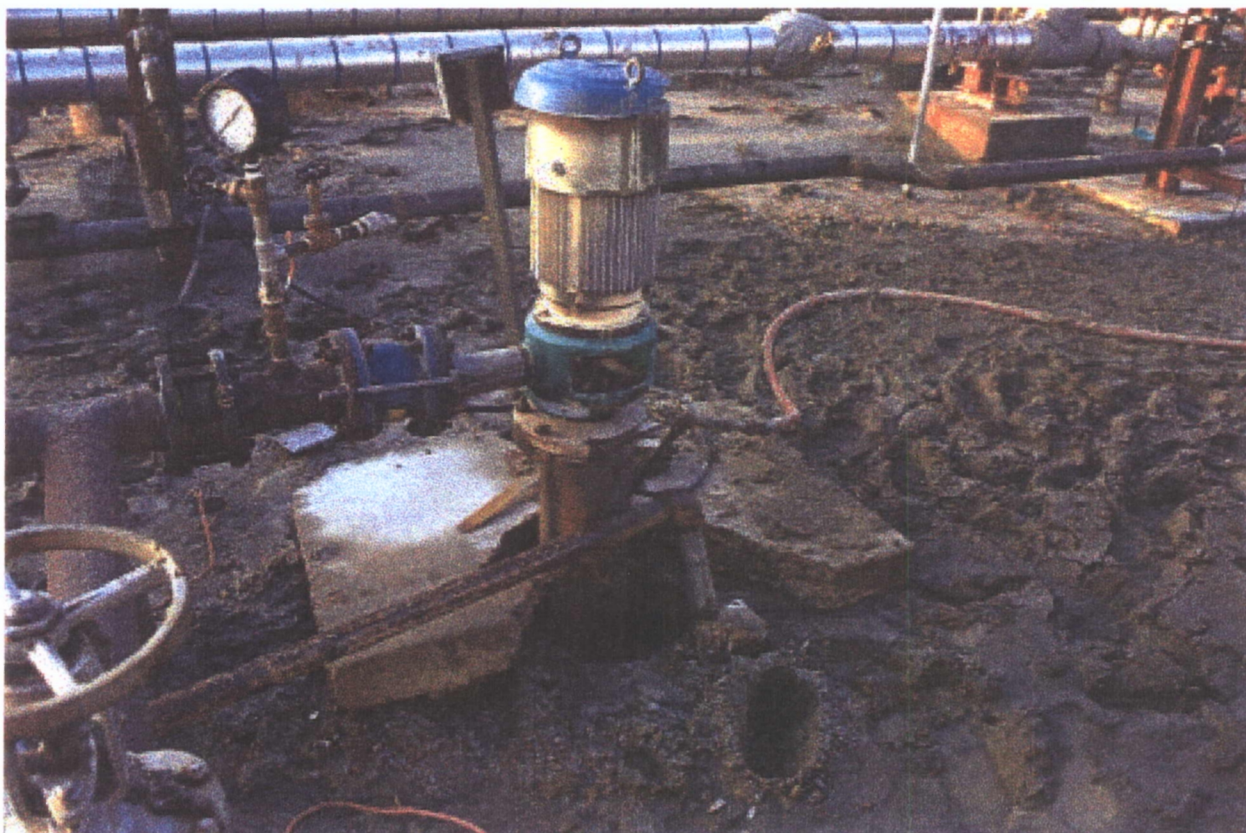
Quenched well on February 2, from the foundation of the separator (north of the well). The 2" pipe from left was used in attempting to quench the well. The concrete cap had cracked behind the upright well casing. Mud is under the concrete, indicating that the cap had been raised while mud escaped and implying that the triangular chunk broke out after some eruption had occurred.

The concrete cap on the well was not heavy enough to contain the pressure from the steam zone once the bentonite liquefied. The cap was unreinforced and broke into several pieces. The small size and fragile nature of this cap may be the reason that this event turned into a large eruption, in contrast to the MW-34 mud eruption, which was easily quenched by existing procedures.

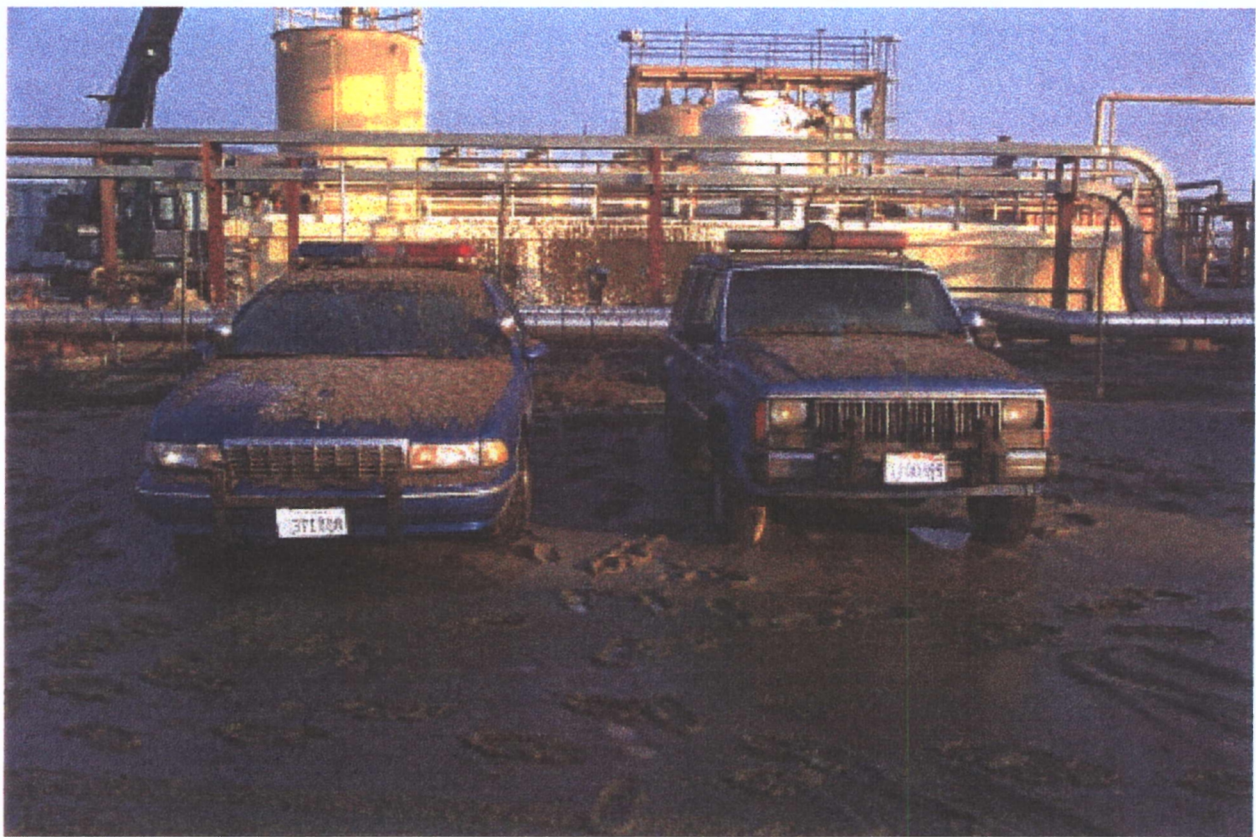
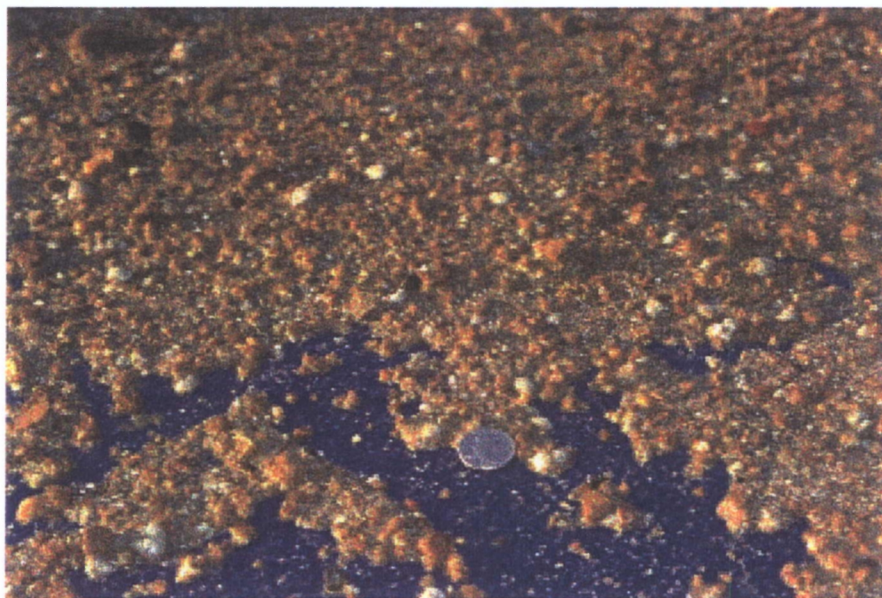
Two types of ejecta were observed on February 2. The majority of the material was fine-grained silt and sand and appeared to be formation material. Some small stones were observed, but very rarely (less than 0.1% of the material). The second type was lumps, 1/4" to 1" in diameter, of bentonite clay from the completion material. This material was found only within 25 ft of the well, predominantly within 10 ft. Material this close to the well appeared to be well-washed by water fall from the plume, but bentonite was always under the other material and often firmly stuck to pipes and to the side of the separator. This may be interpreted to mean that the bentonite came out first and at a lower velocity than the later ejecta.

Ejected mud and silt. Lower photo shows detail from the back of the police sedan. Chunks are almost all bentonite; quarter is for scale. Well EW-5 can be seen in the background between the vehicles. Silt depth in front of these vehicles was about 1 inch.

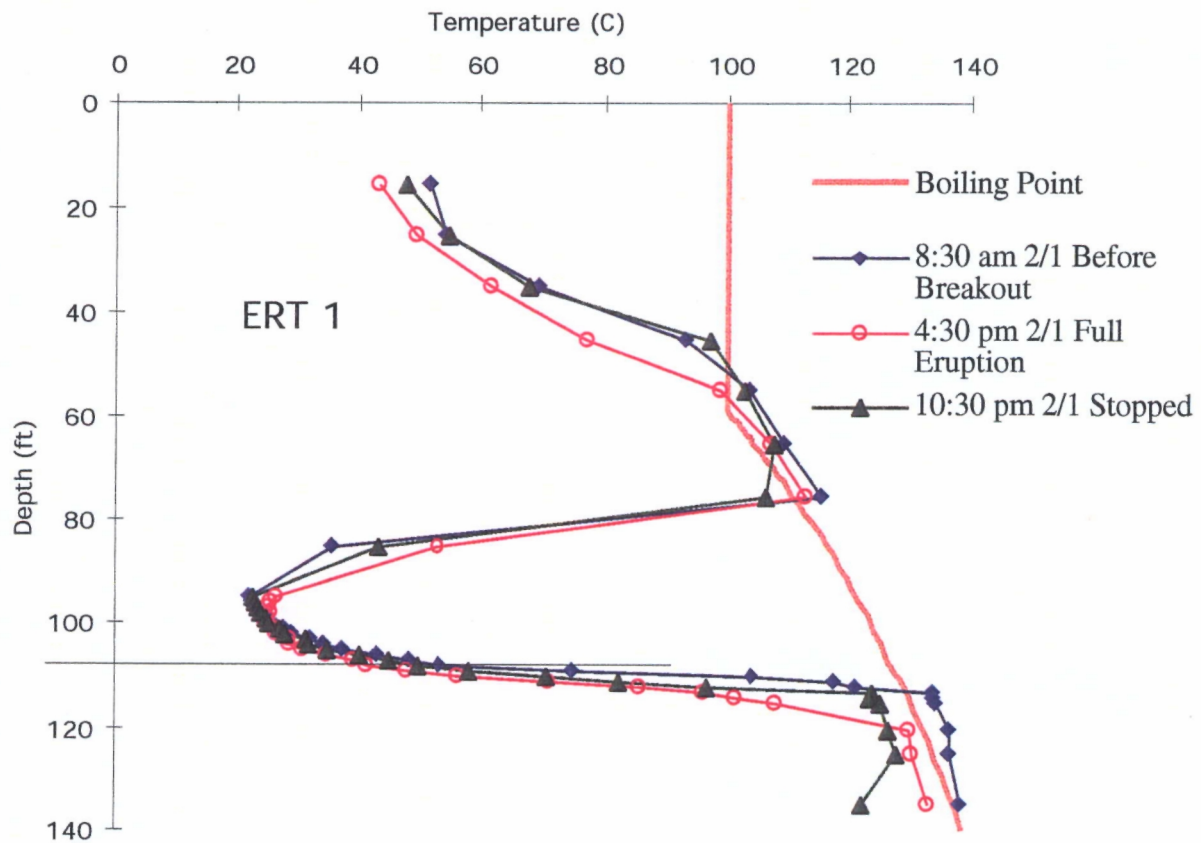
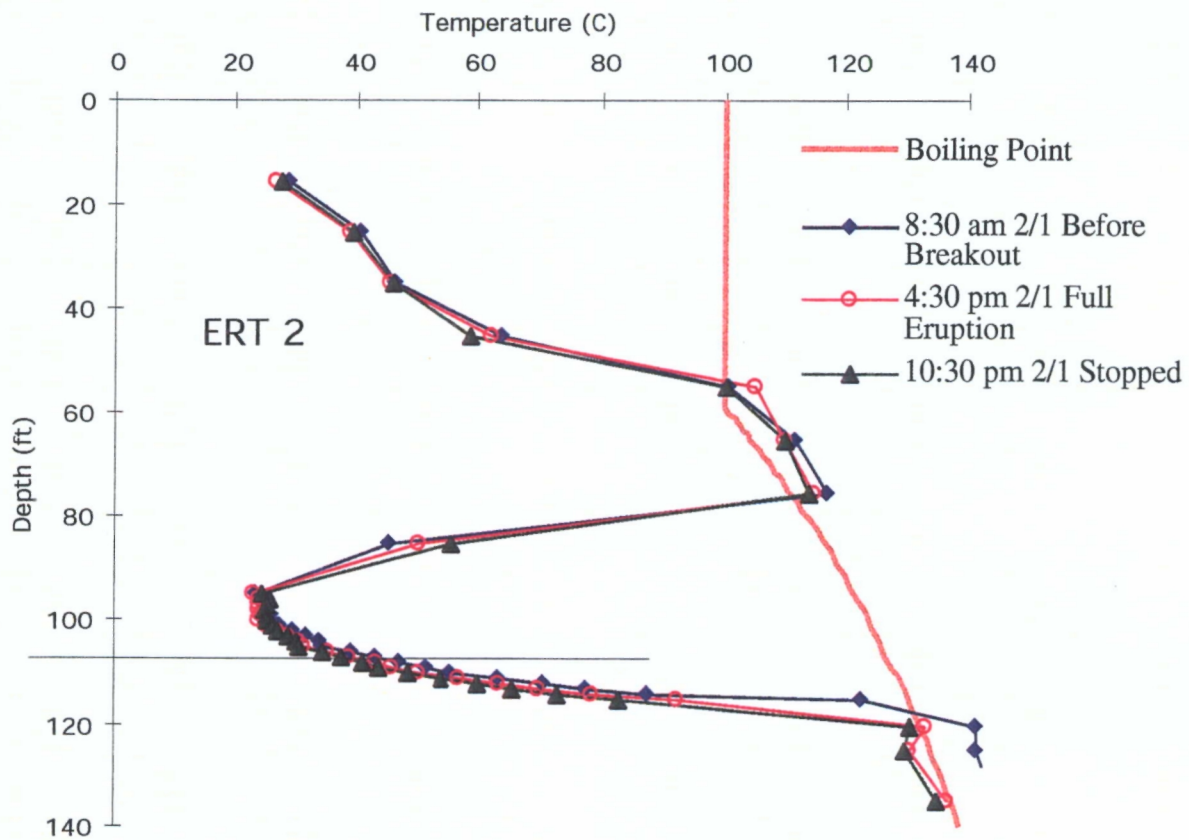
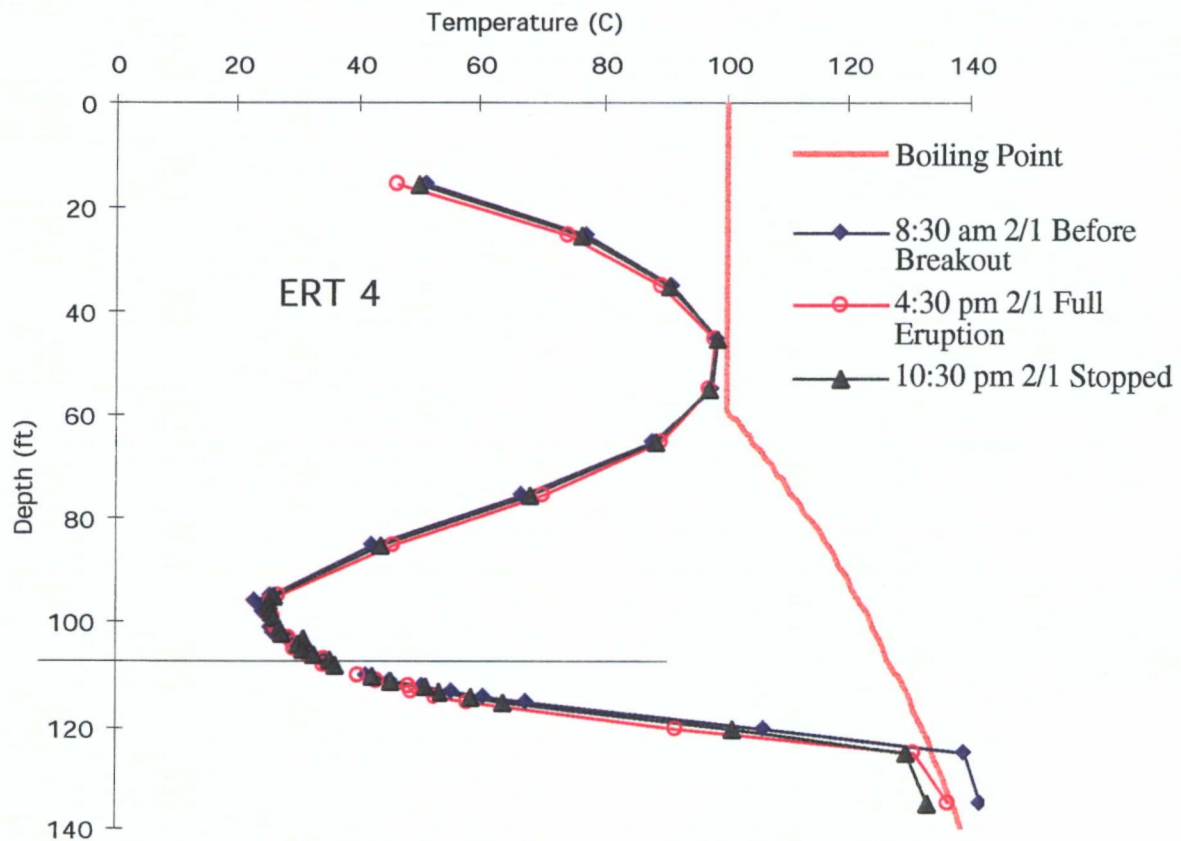
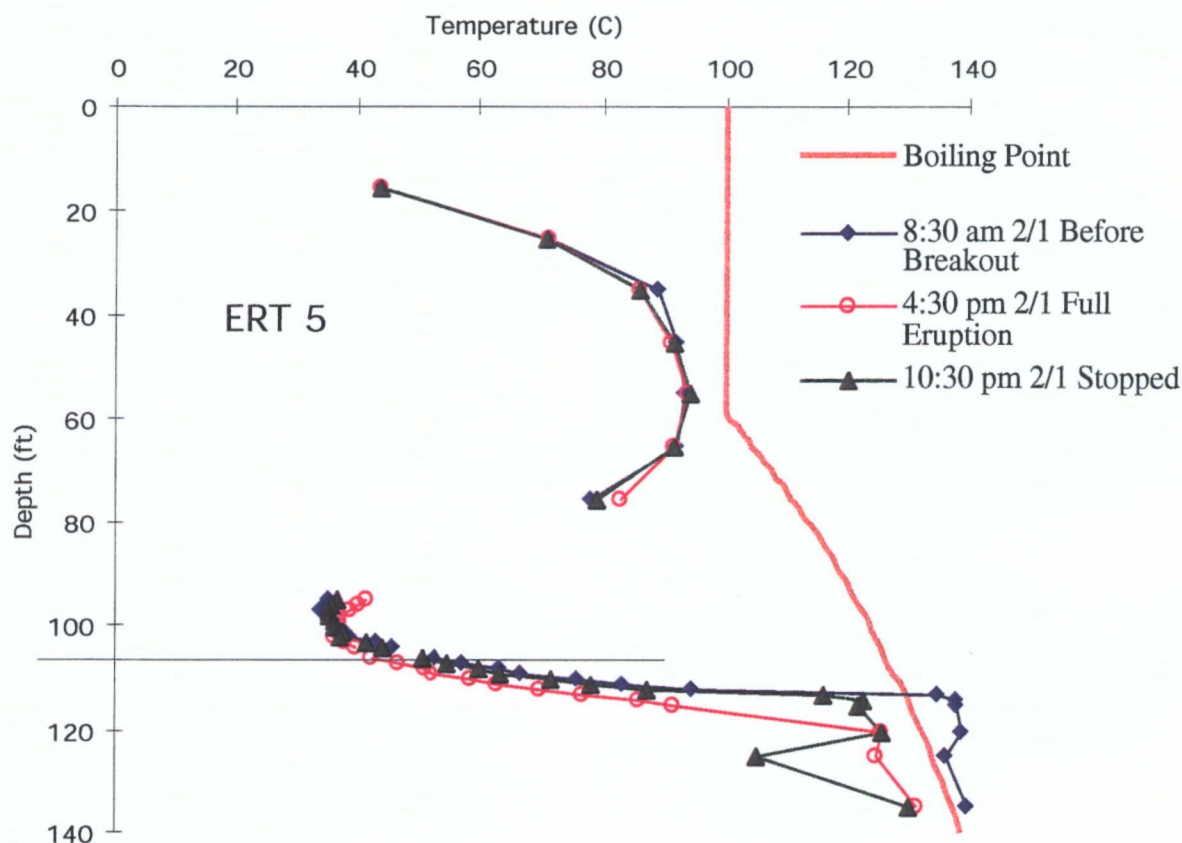
Temperature logs indicate that the entire aquifer was producing steam, and that most of the heat loss occurred in the aquifer from 115 to 135 ft. The aquitard from 107 to 115 ft showed little permanent temperature change in the monitoring wells, which may have experienced different flow than the region of well EW-5. Based on this data, however, it appears that steam flowed through the aquifer horizontally to the EW-5 well, where vertical flow eroded the aquitard material as it passed up and into the casing at 107 ft. The soil removed by the eruption appears to have been consistent in mineralogy and chemistry to that originally logged just below the conductor casing in the drilling of this well. Electric casing logs run after the eruption showed potential voids from about 100 ft to 130 ft, the top of the screened zone. This area accepted approximately 24 cubic yards of grout after the casing was perforated.

Figure 3. Temperature profiles as a function of depth for the four closest monitoring wells before, during, and after the eruption on February 1, 1999. The horizontal line is approximately at the depth of the conductor casing. The boiling point line is calculated from water levels in the two aquifers (hence the small offset at about 110 ft; the lower aquifer has a head about two feet taller than the upper). This calculation may not precisely reflect the natural boiling point in all locations—e.g., ERT-2 appears to be slightly above the calculated boiling point in the upper regions, for which there is no apparent lithologic or hydrologic basis. Breaks in the curves (e.g., at 85 ft in ERT-5) indicate failed thermocouples. The notable offset in the full-eruption temperatures in ERT-1 are probably due to the presence of water in the temperature monitoring tube, slightly supported by a steam bubble near the bottom. When temperatures collapsed, the bubble collapsed and allowed water in the tube to drop lower. This caused a temporary offset in the observed temperatures. This log indicates that the water dropped several feet. The formation temperatures quickly re-equilibrate the water in the tube, which is 2" in diameter and filled with sand.
